# CORNERSTONE HOME INSPECTIONS

This home inspection report was prepared by **Aaron Phillips** o/a **Cornerstone Home Inspections** for **SAMPLE** on **MONTH DAY, YEAR**, at **ADDRESS, CITY**. This home inspection was done to the Standards of Practice of the International Association of Certified Home Inspectors.

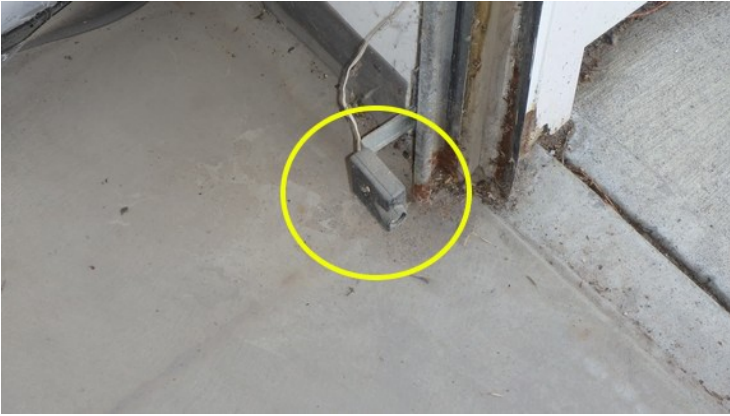
2.07

**Garage door automatic reverse sensor.** Door will not operate properly if beam is broken or sensor is removed.

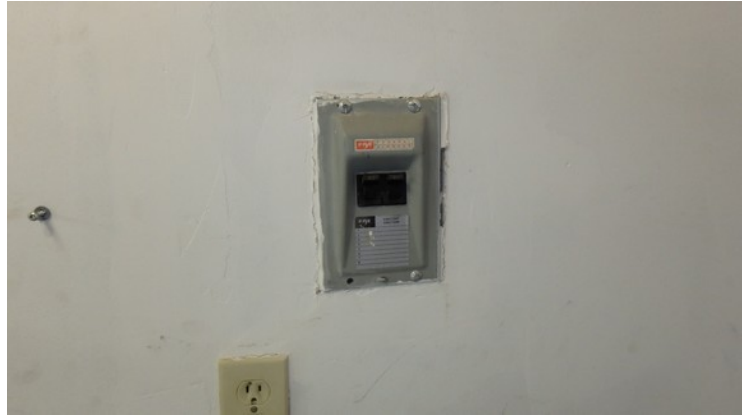
2.08

**Sub-panel.** Located in garage.

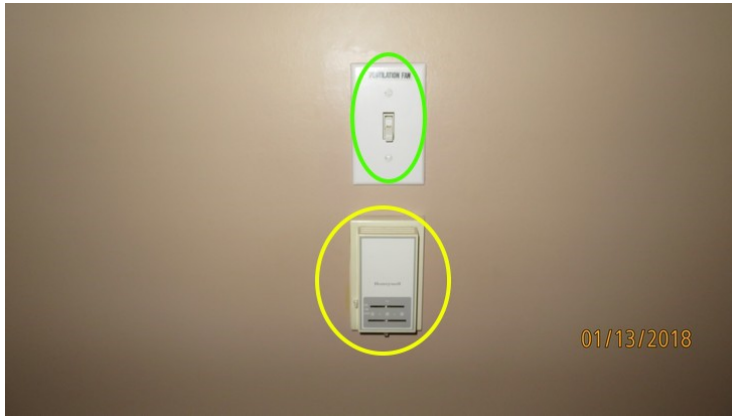
2.13

**Thermostat (yellow) and humidifier (green) controls for furnace.**

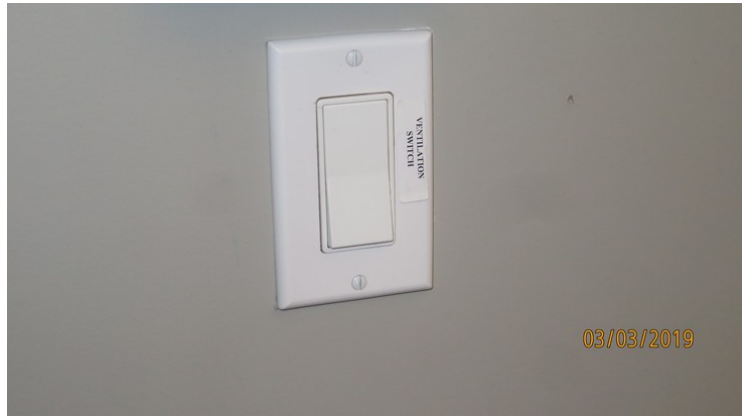
2.14

**Whole house ventilation.** Circulates the indoor air with fresh air while removing moist, stale, polluted indoor air.

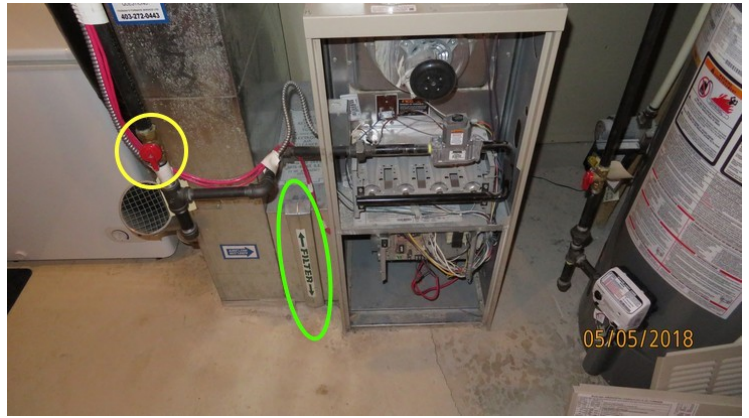
2.16

**Furnace with fuel shut off (yellow) and air filter (green).**

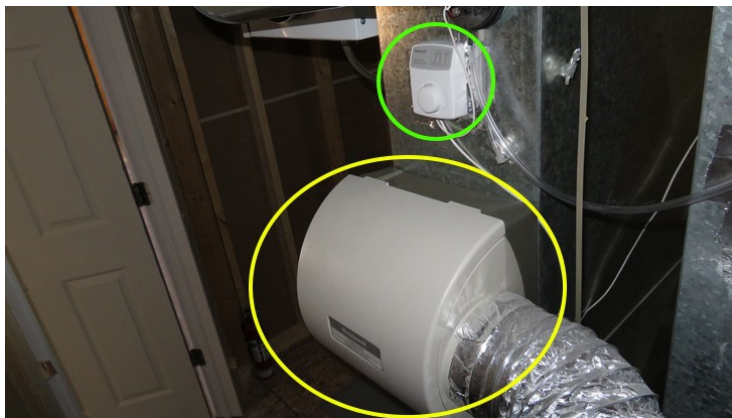
2.17

**Humidifier (yellow) and controls (green).** Recommended to leave off / disconnected.

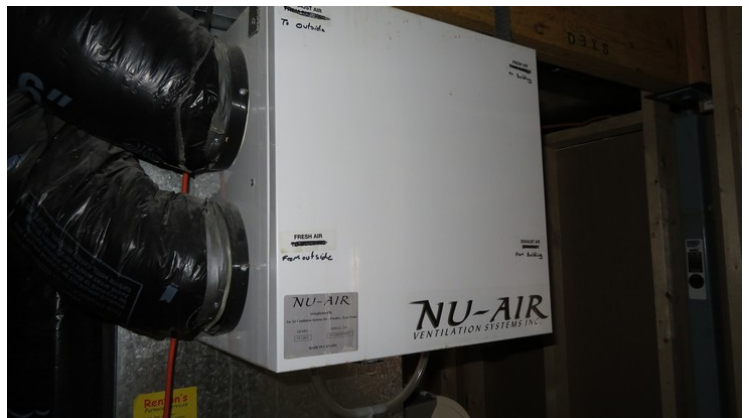
2.18

**Heat Recovery Ventilator (HRV).** This is a system designed to transfer heat from indoor air being vented out, to outdoor air coming in, without mixing the air by using a heat exchanger.

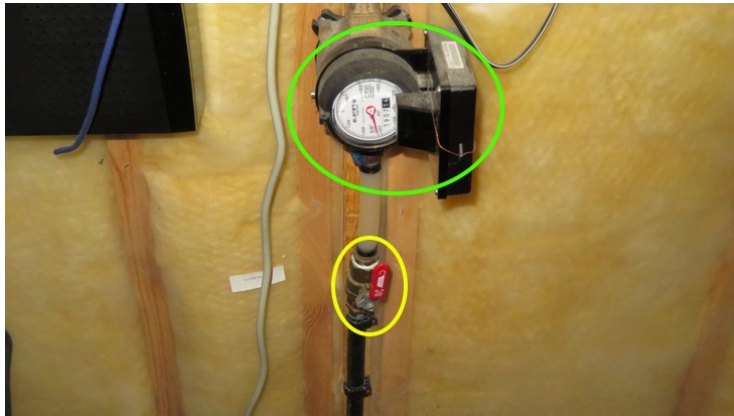
2.19

**Main water shutoff (yellow) and water meter (green).** Use shutoff only in emergencies or for certain plumbing repairs. The water meter is property of the City of Calgary.

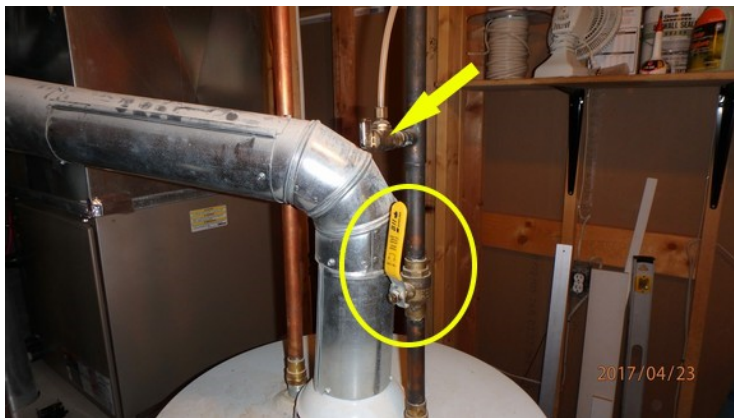
2.21

**Cold water shutoff for water heater (yellow) and humidifier water supply with shutoff (green).**

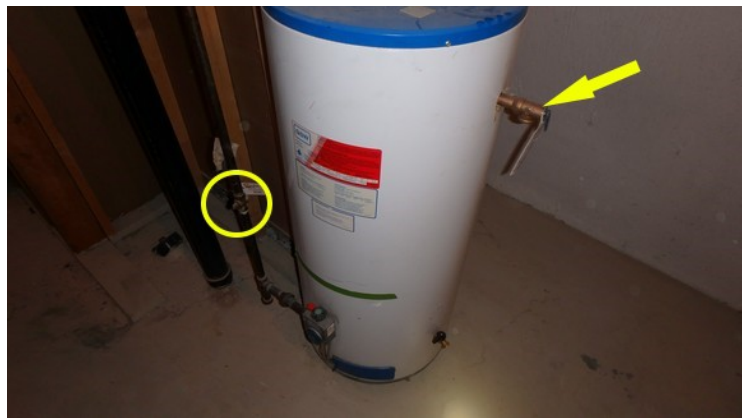
2.22

**Water heater with fuel shut off (yellow) and TPR valve (green).** TPR valve is a safety device, do not tamper with it.

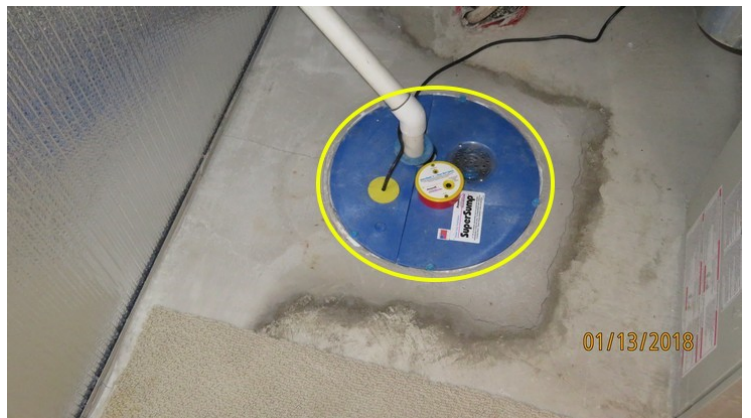
2.24

**Sump pump in appropriate sump pit.**

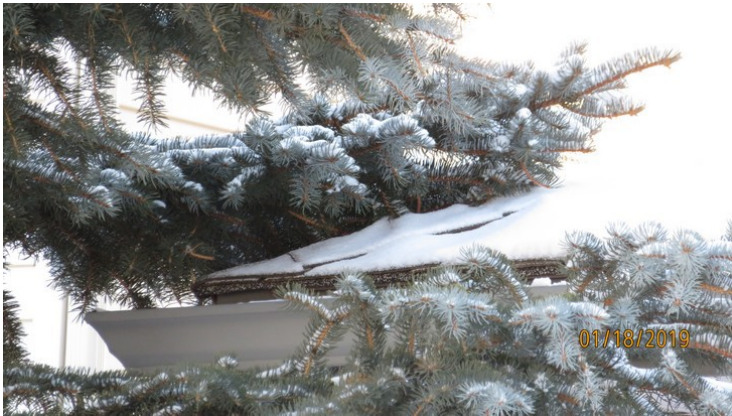
4.01

**Branches overhanging and in contact with the roof.** This prevents the roof from drying properly, causes physical damage and increases maintenance needs.

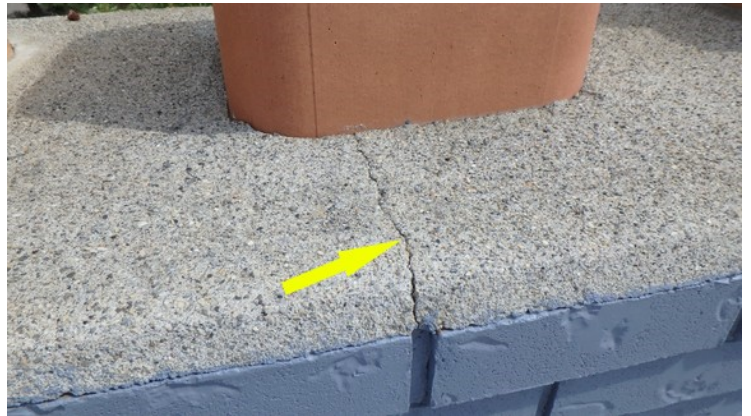
4.02

**Crack in chimney.** Exterior cracks should be sealed (protected) to help prevent deterioration.

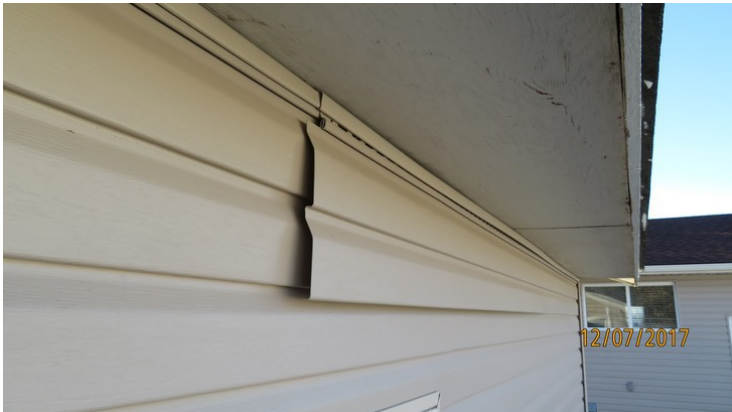
4.03

**Loose section of vinyl siding.** Sometimes they can get blown off during wind storms.

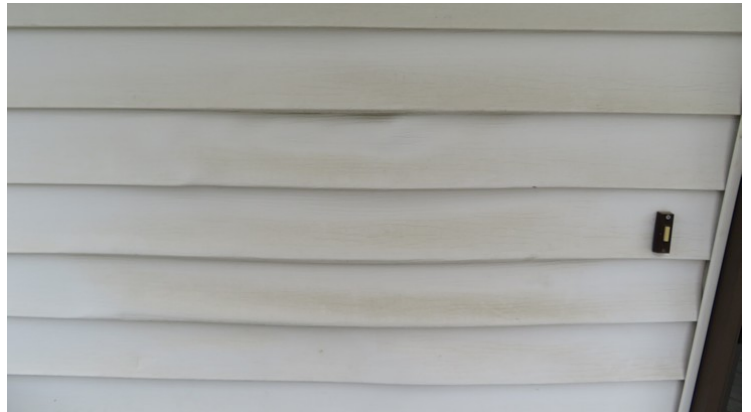
4.04

**Warped vinyl siding.** This is almost always caused by a barbecue being too close to the siding, keep barbecues at least 3 feet from combustible materials.

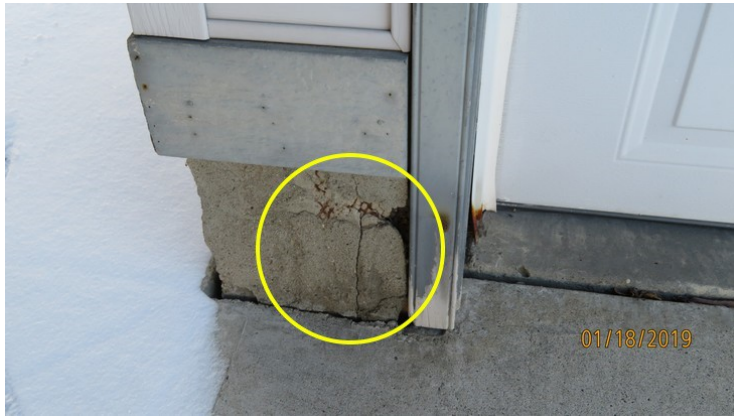
4.07

**Damage parging.** Once parging cracks and weakens, it can start to fall off. See 4.08.

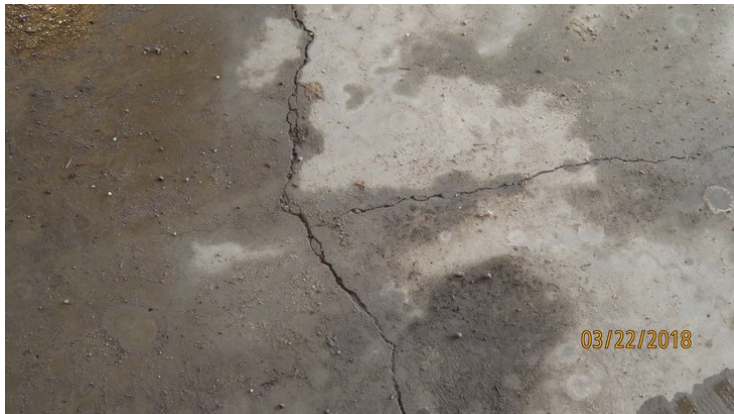
4.09

**Driveway cracks and garage floor cracks are important to fix (seal).** This is because vehicles cause additional wear to the concrete and they can bring salts, oils, etc., which can also wear out the concrete faster.

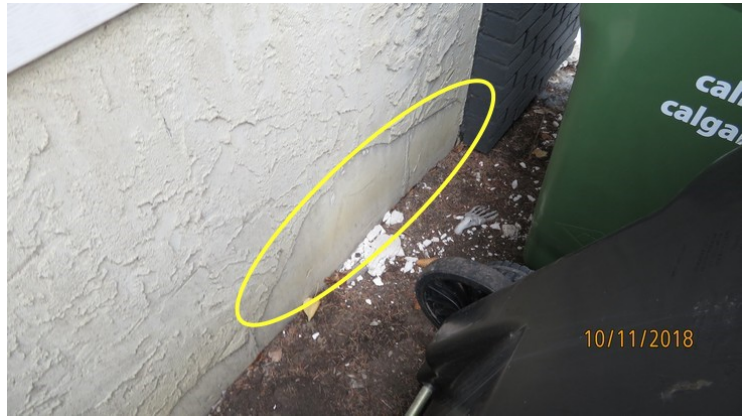
4.08

**Missing parging.** The parging helps protect the concrete foundation.

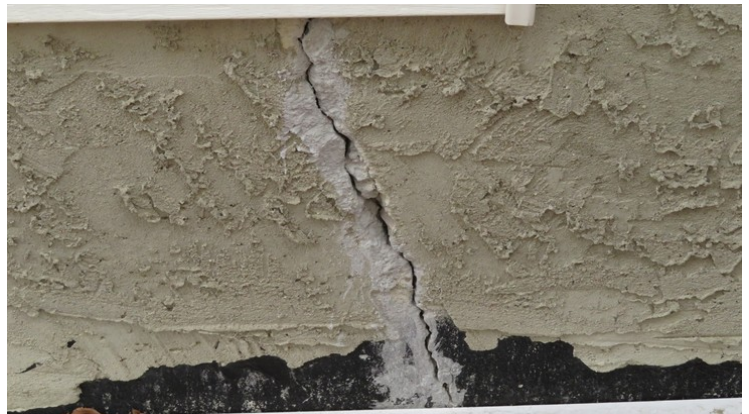
4.10

**Foundation cracking.** Concrete cracking is normal. I assess each crack, larger cracks such as this one should be filled, but are not generally a structural concern.

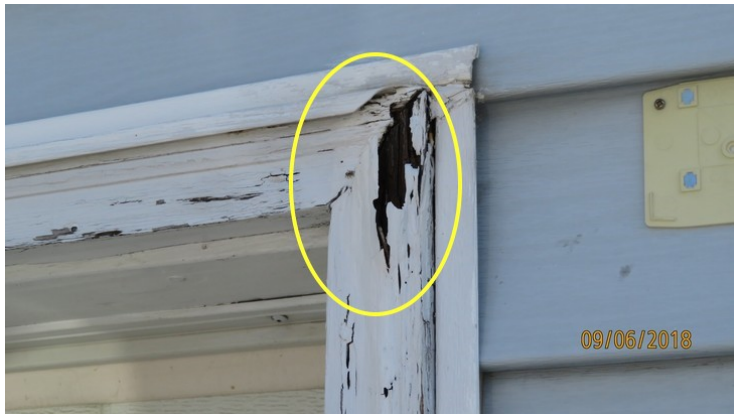
4.11

**Rotting wood.** Wood requires paint or other treatments to prevent rot, when neglected this can happen.

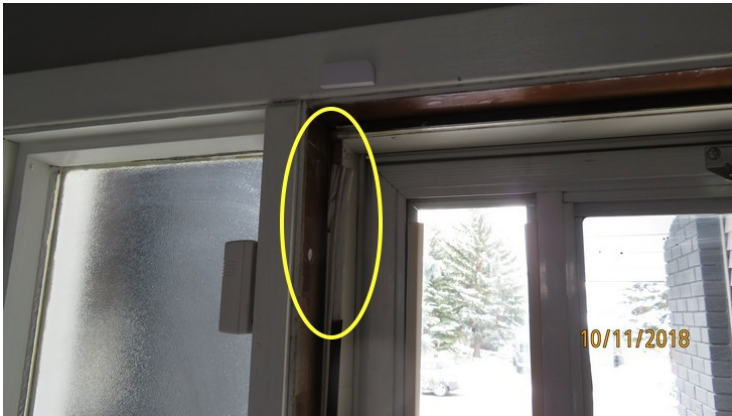
4.13

**Incomplete weather stripping.** Even a small section like this can cause drafts and reduce heating efficiency.

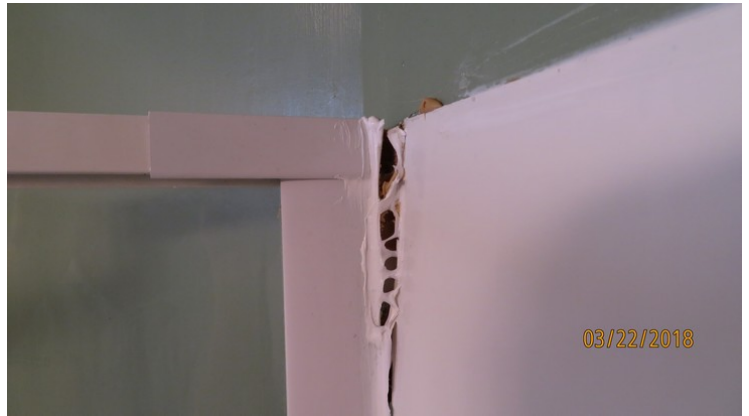
4.14

**Shower wall separation.** This shower was not properly installed and relied on caulking to hold it together.

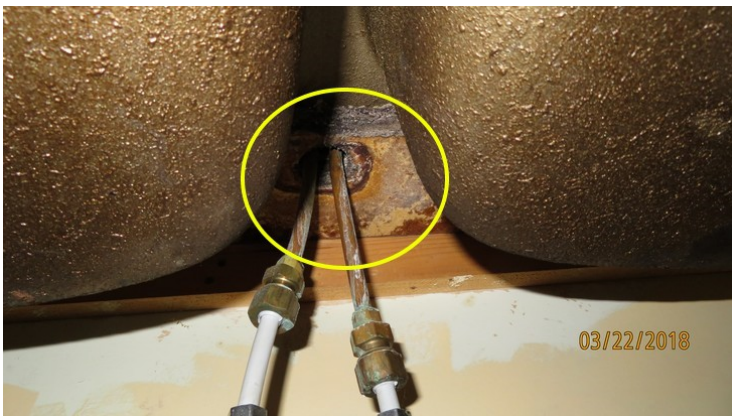
4.15

**Missing faucet hardware.** This faucet was very loose, the underside should have a faucet bolt and nut assembly to hold it in place.

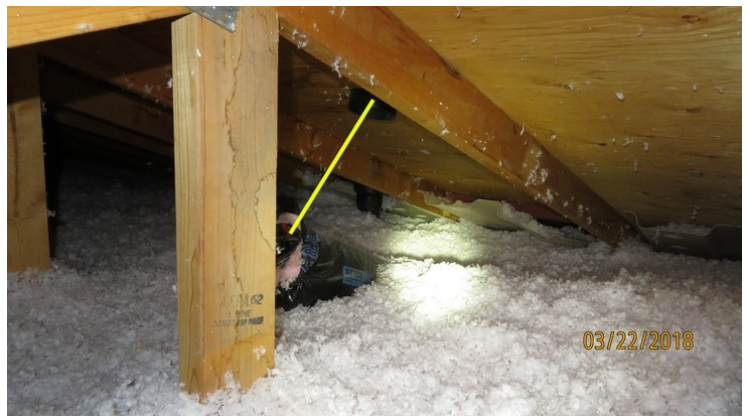
4.16

**Bathroom fan duct is detached.** This is a common problem which can result in moisture entering the attic.

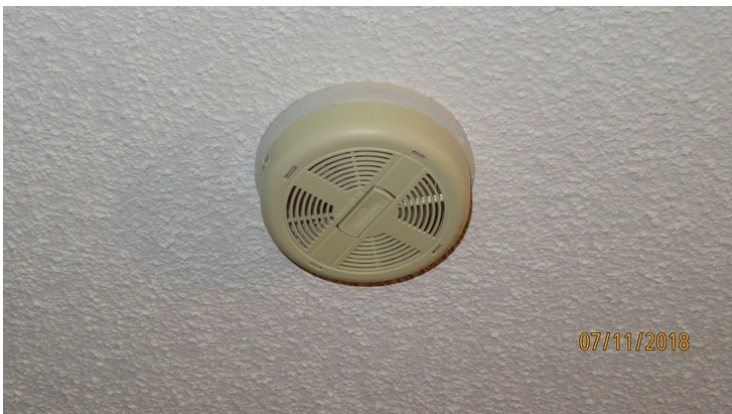
4.17

**Old smoke detector.** It is important to have working smoke detectors. It is also better to upgrade all smoke detectors to smoke and CO detector combination units.

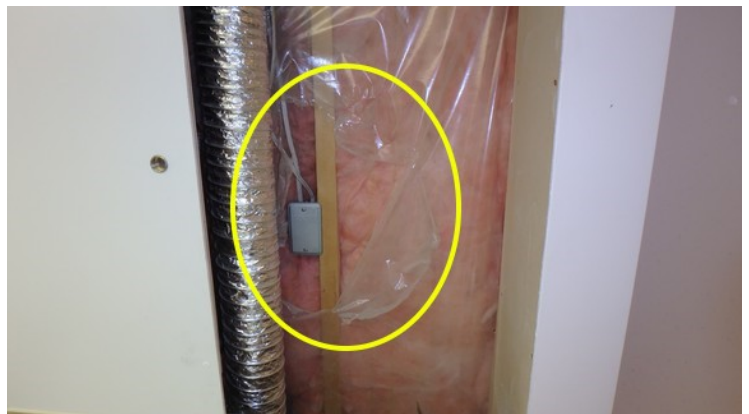
4.18

**Damaged vapor barrier.** When contractors are hired to do a job, in this case an electrician, you should always ensure they finish the job.

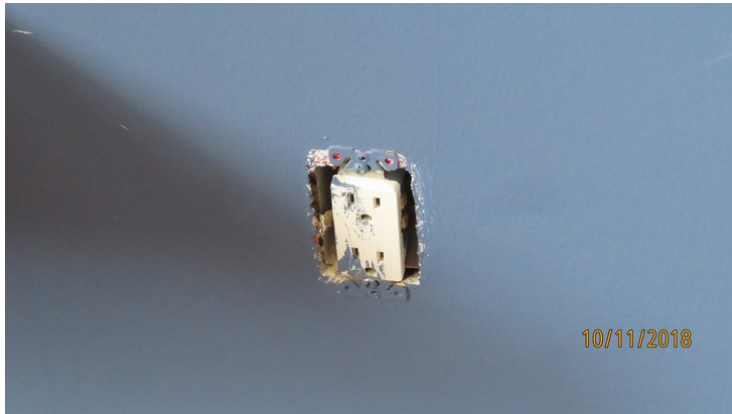
4.19

**Missing outlet cover.** The cover prevents objects from getting into the junction box housing the outlet, which has live electrical wires in it.

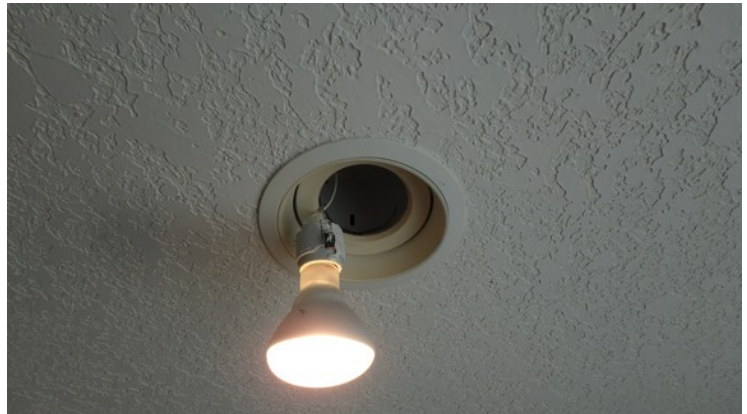
4.20

**Damaged light fixture.** Where ever there is electricity, you do not want damaged products.

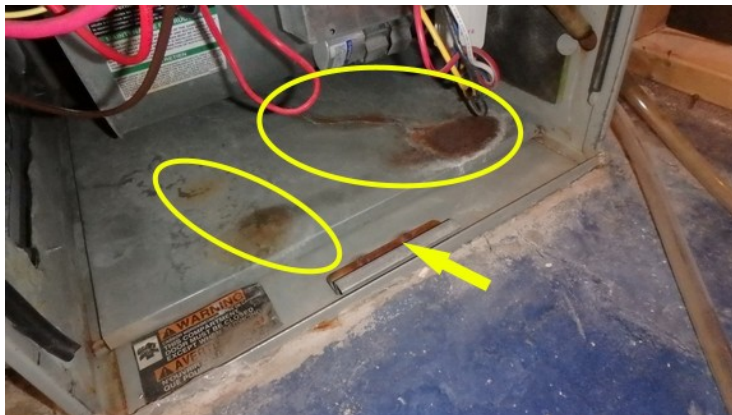
4.21

**Condensate damage in furnace.** High efficiency furnaces generate a liquid by-product of combustion which can damage the furnace. Because of this, high efficiency furnaces require more frequent maintenance. **See comments.**

- 4.21: High efficiency furnaces generate a liquid by-product of combustion called condensate. The condensate needs to drain from the furnace, so do not block or remove the hose from the furnace to the floor drain. Condensate is also corrosive and may leak into the furnace cabinet.

- 4.21: You should regularly check for condensate leaks during cold periods where the furnace is running frequently. If a condensate leak occurs, have the furnace serviced to prevent more significant problems from occurring. At a minimum you should check for rust or condensate every time you change the filter.

- 4.21: High efficiency furnaces should be professionally serviced at least once every 2 years or as required by the manufacture recommendations.

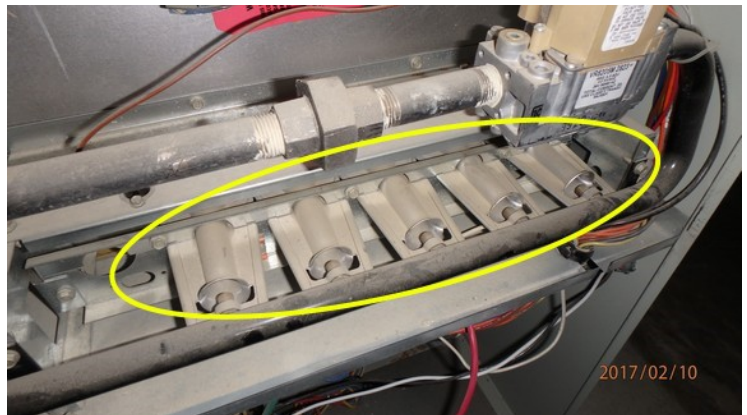
4.22

**Dirty burners.** While older furnaces are more reliable and have less that can go wrong, when maintenance is neglected they are more likely to break down.

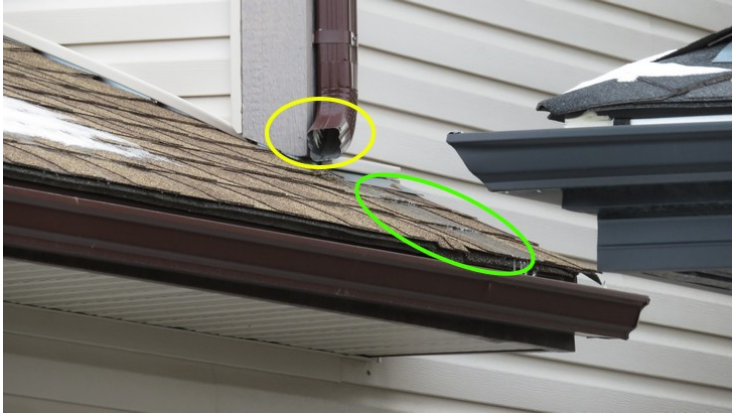
5.01

**Downspouts from upper roof discharges onto lower roof.** This can wear out the shingles prematurely, extending to the lower gutter is better.

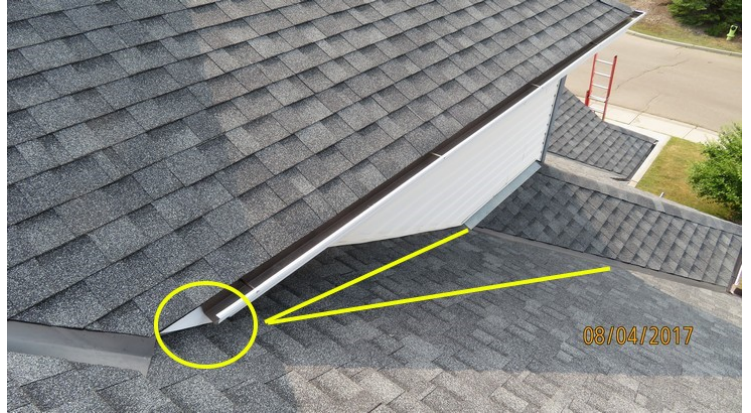
5.02

**Gutter missing end cap and downspout.** This is a common problem which roofers do. This can wear out the shingles prematurely.

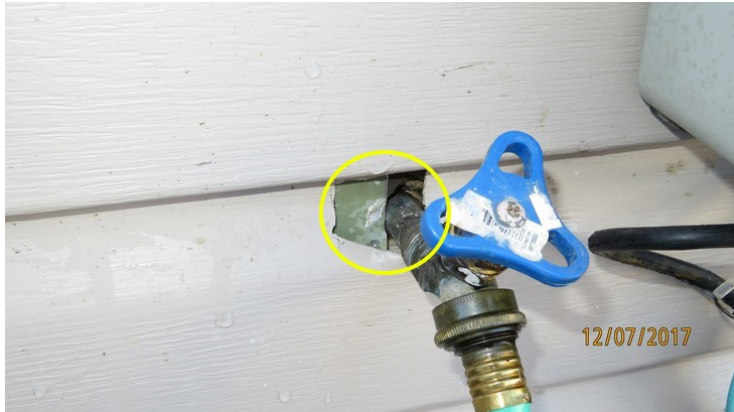
5.07

**Penetrations through the building exterior should be sealed and this hose bibb needs a mounting plate.** Unsealed penetrations cause drafts and can allow moisture or pests into the building. Without a mounting plate to secure the hose bibb to the wall, the water line can easily get damaged causing a water leak or even a flood.

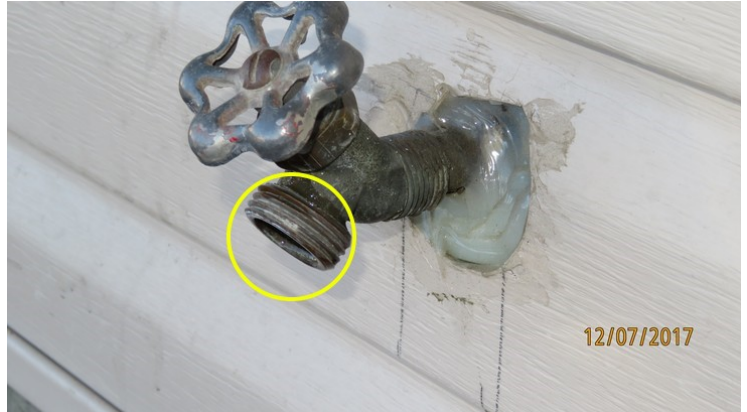
5.08

You can see here that this hose bibb is also missing a mounting plate and has recently been sealed.

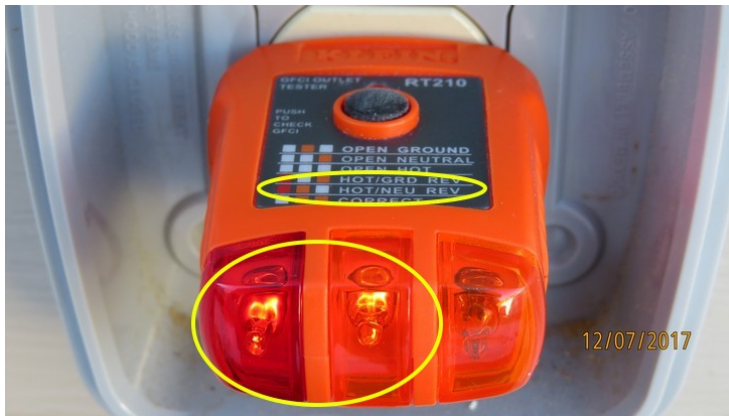
5.13

**Hot and neutral are reversed.** This means electricity is essentially flowing in reverse. Most appliances will work as intended, but some may have safety risks involved.

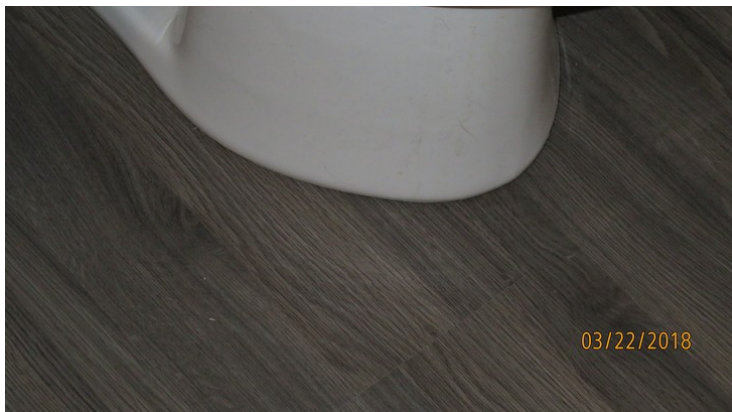
5.15

**Toilets should all be caulked to the floor.** Some defects are a matter of opinion. For this defect I am for caulking the toilet to the floor for daily hygiene reasons, while some people are against it because a broken toilet floor seal may go unnoticed for longer. I see it as a daily problem vs a once in a 20 year problem.

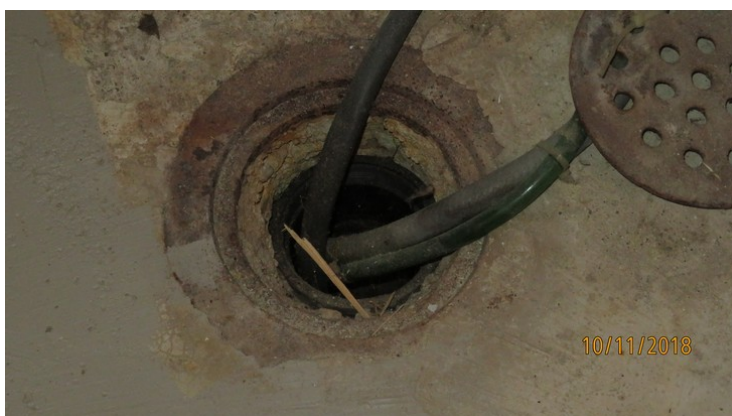
5.17

**Floor drain cover has been removed.** While seemingly minor, it is recommended to keep the drain cover on with the drain tubes on top of the cover. This is because larger objects could fall into the drain causing it to clog.

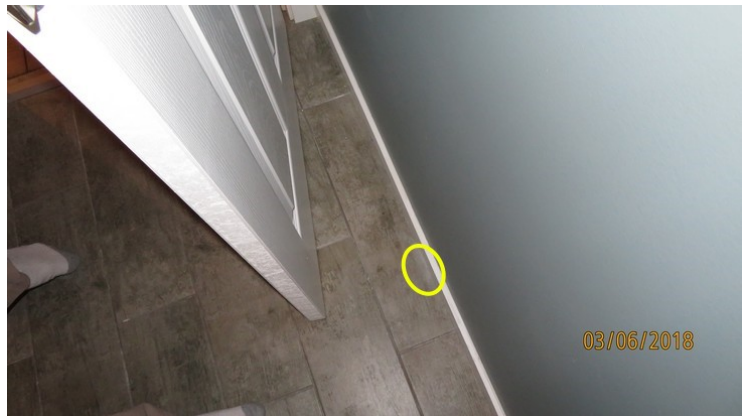
5.14

**Missing door stopper.** Not all issues are technical, some are just simple things that can get overlooked.

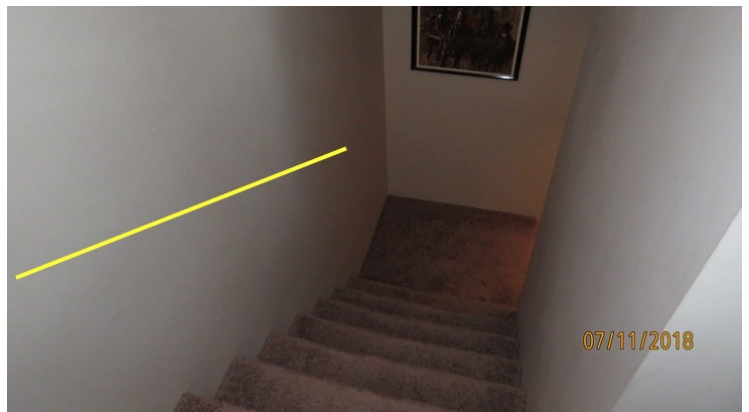
5.16

**No handrail.** While it may seem obvious, it is easy for people to overlook defects like this.

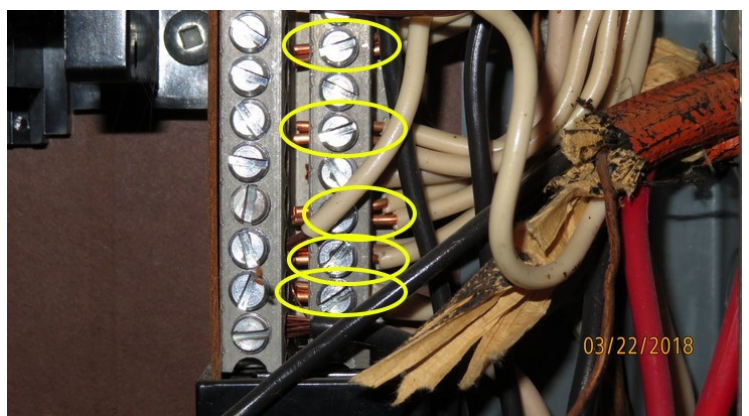
5.18

**Double tap.** Each neutral lug should only have one wire. This is a common problem found with most panels and often with the breakers as well.

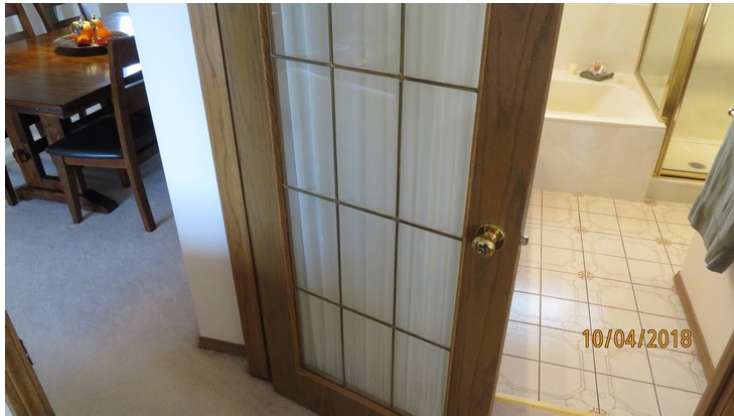
5.19

**Glass doors are not recommended.** They break easily and if there are children living in the home or will visit even occasionally, the chance of it breaking goes up greatly.

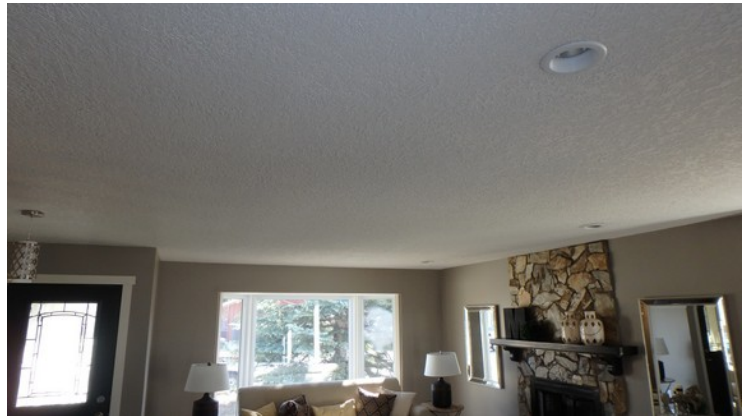
5.20

**Missing smoke detector.** Floors which have a fireplace require a smoke detector.

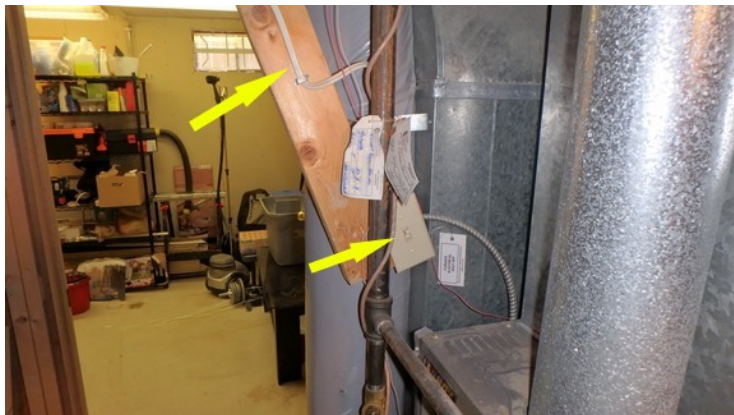
5.21

**Improperly installed furnace shut off switch.** Many defects are a home owners solution to a problem they have when renovating or wanting to change something. Most of the time the defect is still functional, but is technically wrong.

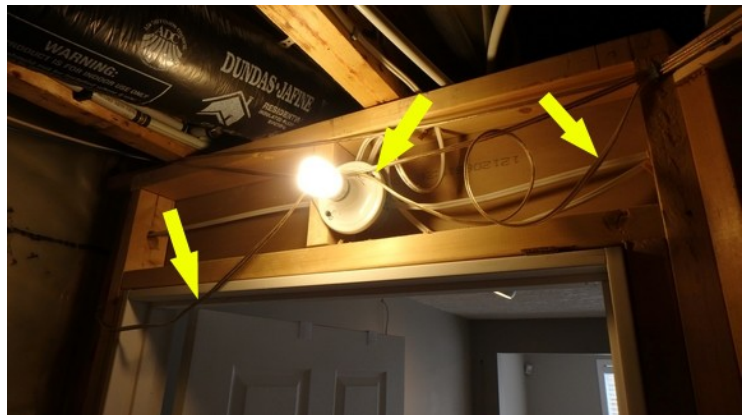
5.22

**Improperly installed electrical wire.** Loose, left hanging on the light fixture and cutting across a doorway, three problems in one picture.

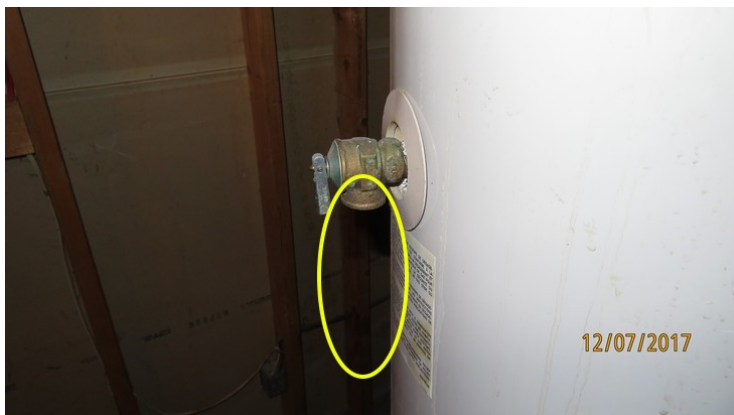
5.23

**Missing TPR valve discharge tube.** The TPR valve is a safety device which will discharge nearly super heated water if the water heater fails. Without the tube, boiling water will spray everywhere, instead of at the floor level as it should.

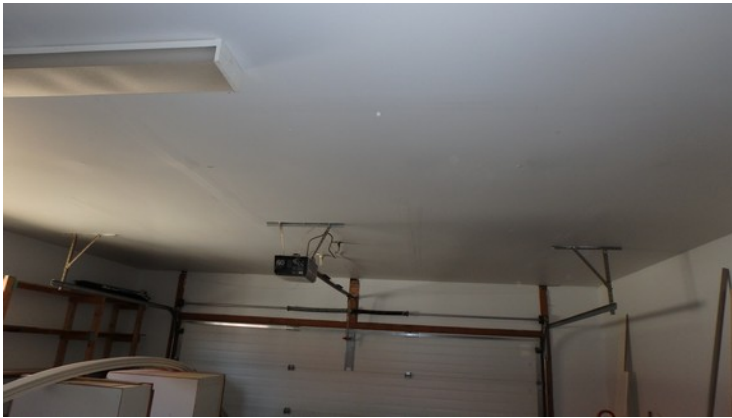
5.27

**No attic access hatch in garage.** This is surprisingly common and while not a huge issue on its own, it is not recommended.

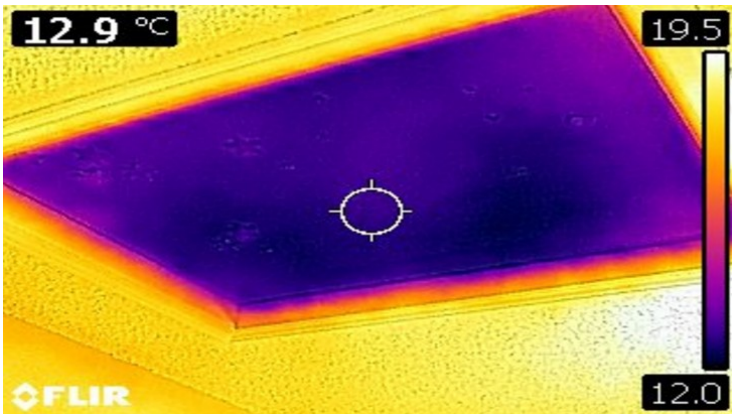
5.29

**Missing attic hatch insulation.** The dark purple is a dead give away, but even without thermal imaging, this issue would have been found. See 5.30.

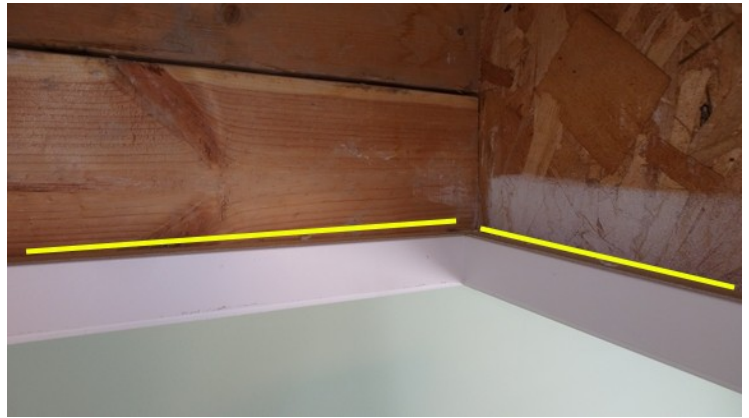
5.28

**Missing attic hatch seal.** This is one the most significant sources of heat loss and drafts. Additionally it can lead to moisture damage in the attic.

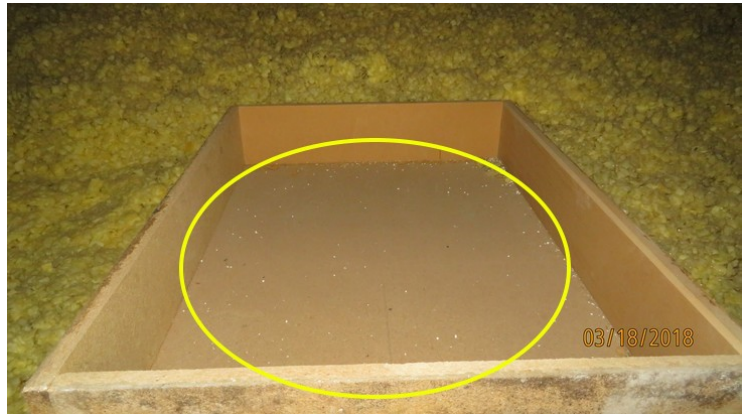
5.30

**Missing attic hatch insulation.** This creates a cold spot which will allow heat loss and can make the space around the hatch inside the home uncomfortable.

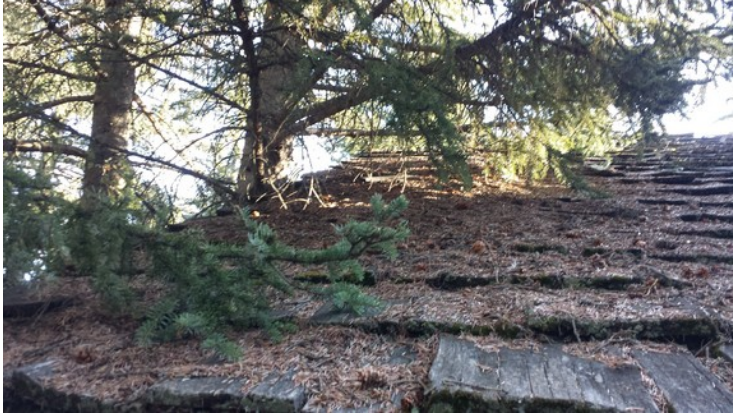
6.01

**Branches overhanging and in contact with the roof.** See 4.01 on page 12. This is an example of the same issue can scale. This roof here has been neglected for a long time and the roof is now damaged, requiring it to be replaced.

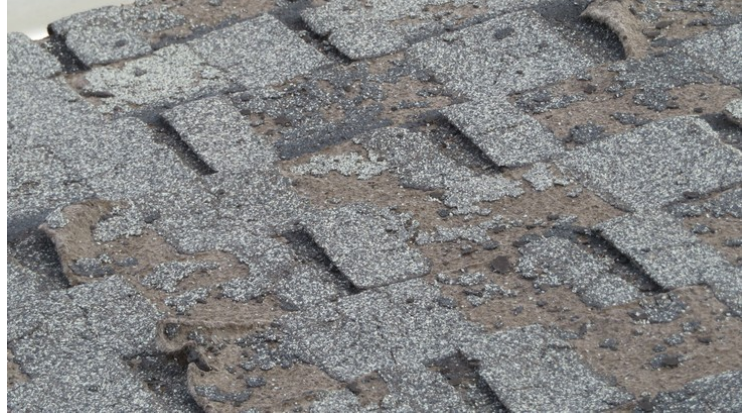
6.02

**Roof has expired.** When a significant portion of a roof has deteriorated to this point, it is time to replace it.

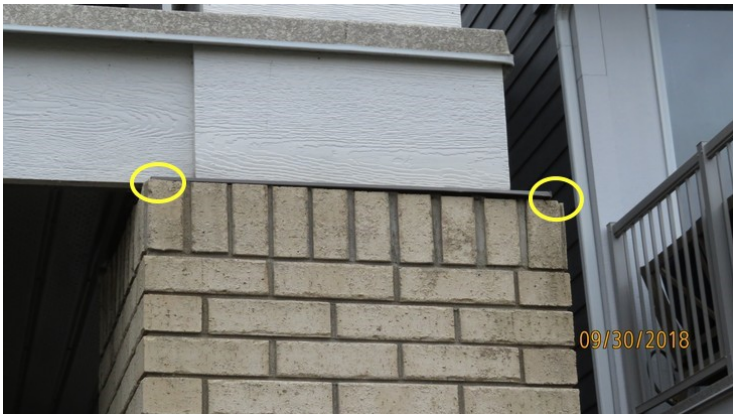
6.03

**Deck column has shifted.** This has created an unstable deck which has begun to pull away from the building. Without fixing the source of the problem, the deck could collapse. See 6.04.

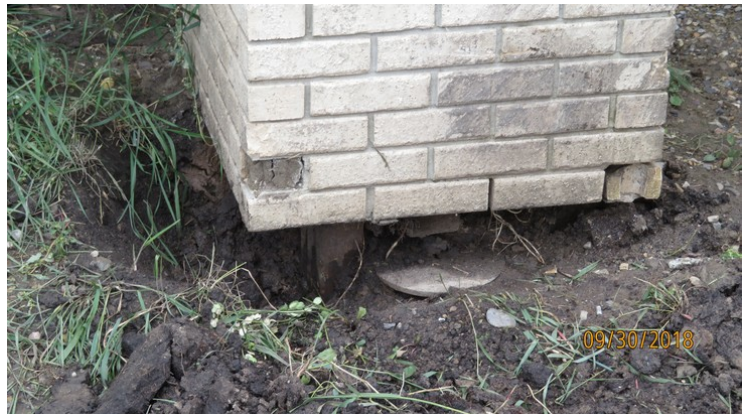
6.04

**The footing for the deck column was not properly installed.** This caused the weight of the deck to push the column down and away. Freeze thaw cycles and moist ground can also contribute to this problem.

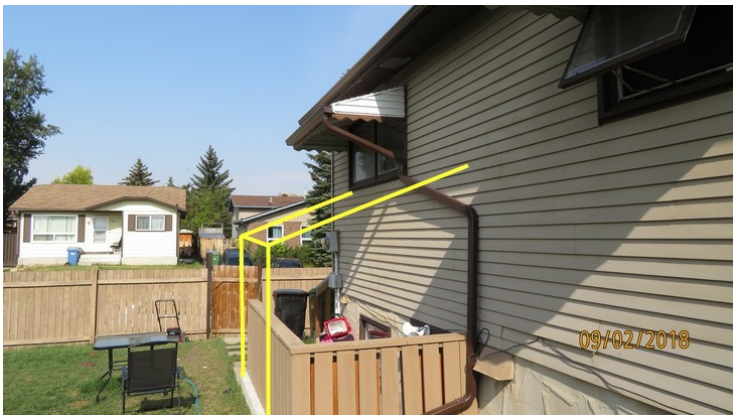
6.05

**Basement walkout requires covering.** This is especially true if renting out the basement (as in this case, was the intent of my client).

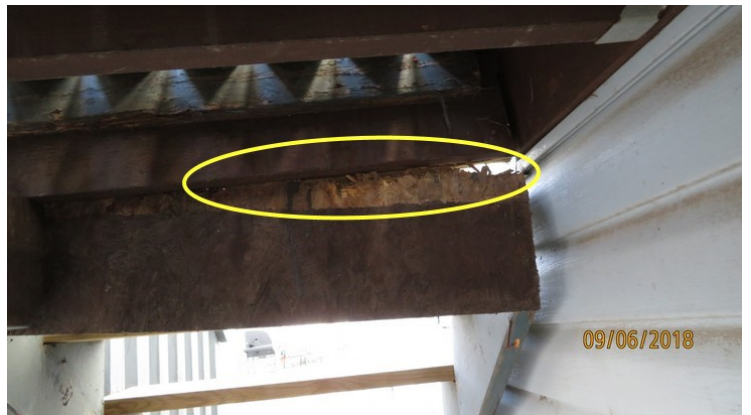
6.06

**Deck steps were improperly installed and are about to collapse.** If I walked up these steps there would be a good chance they would collapse.

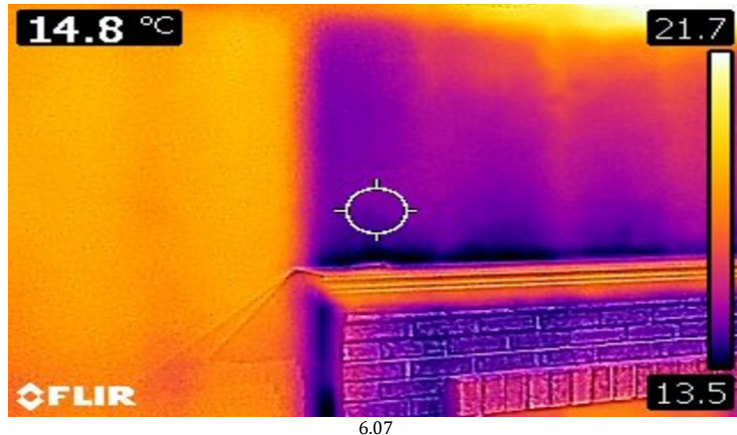
### Thermal imaging revealing missing / incomplete insulation.

For an issue like this, the affect is minimal, but correcting the problem is not easy. Having this information in advance is important when buying a home.'

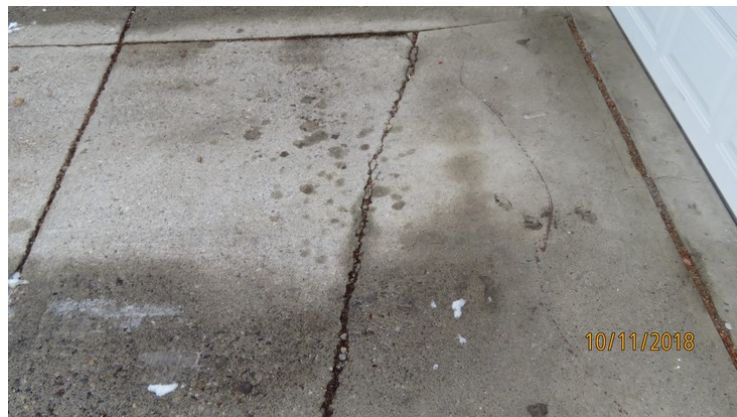
**Sunken concrete pad of driveway.** This is often a result of improper installation, where the ground was not compacted fully. With the concrete cracked and sunk in as it is, water will cause the ground underneath to soften and the damage will get worse.

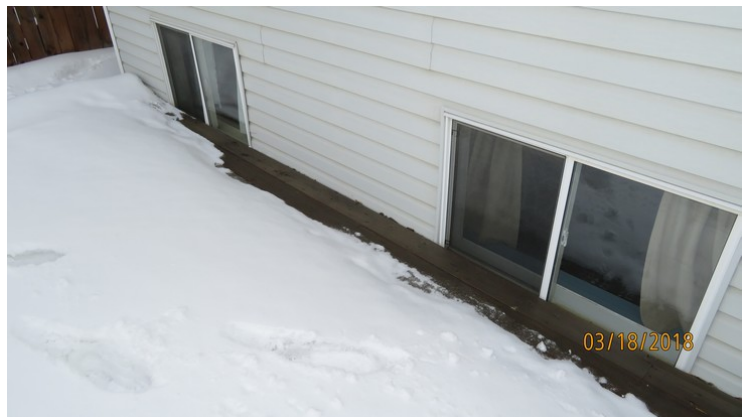
**Deck installed up to windows.** This creates a risk of the windows getting physically damaged / broken. It also will allow snow to accumulate against the windows which will allow moisture into the building.

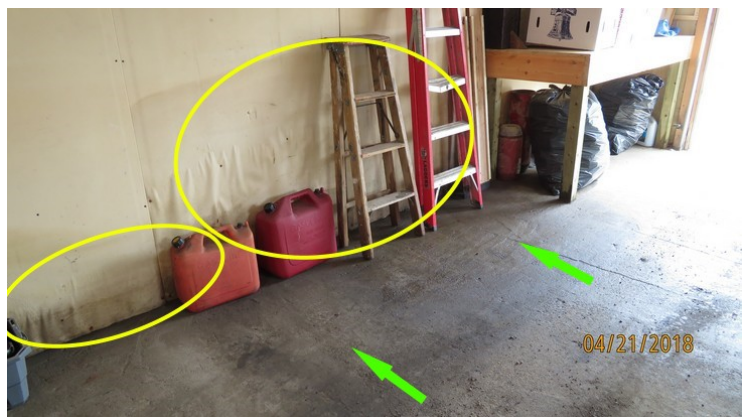
**Garage floor is slopped the wrong way.** Water is not flowing out of the garage, but instead against the wall causing damage.

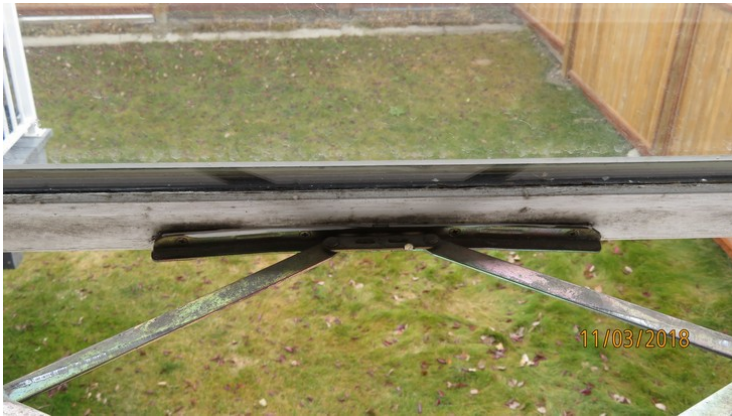
6.13

**Older window hardware is worn out.** As windows age they require replacement. Identifying the windows nearing the end of their life can save thousands of dollars in negotiations.

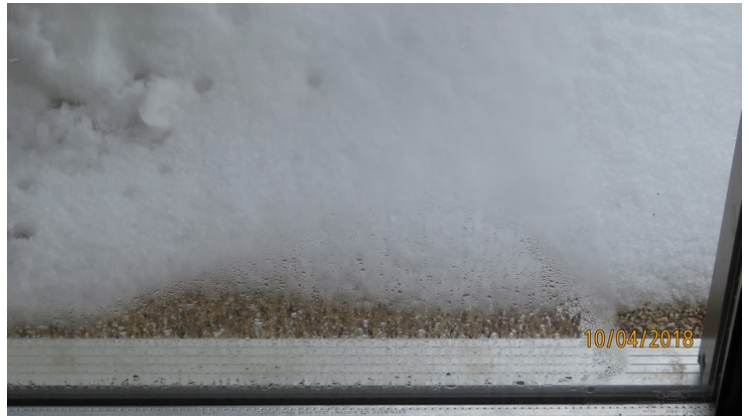
6.14

**Window seal is broken.** While some window seals can be restored, it does not always work and often does not last.

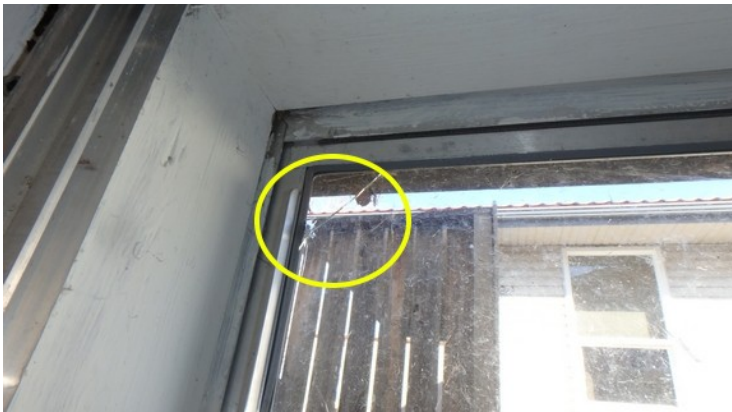
6.15

**Cracked window.** Sometimes details like this are small and get overlooked when you're looking at a house.

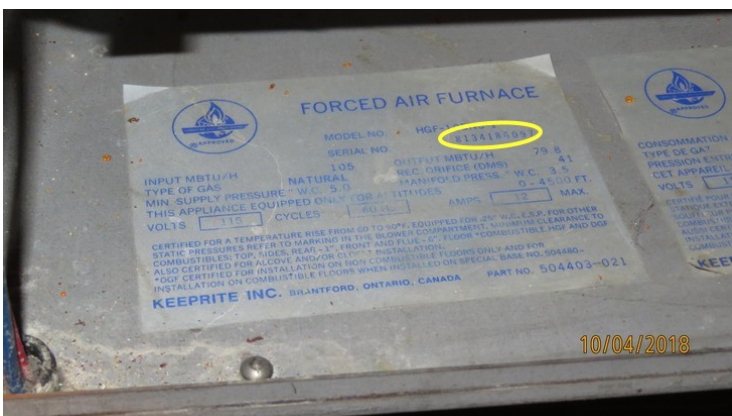
6.17

**I use the manufacturer's serial number to determine the age of the appliance.** In this case, the fireplace is so old the manufacturer does not have public information on it. This is a good indicator that its about time to replace it.

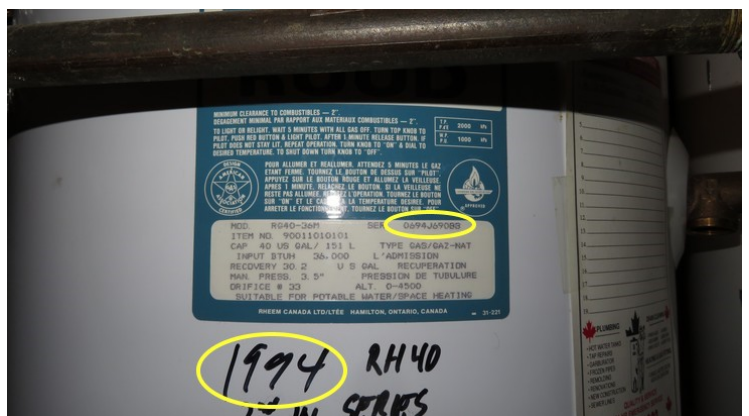
6.18

**Sometimes water heaters last a really long time, but you can't count on it.** This one was 24 years old and is officially the oldest I've ever seen. It didn't work very well and it was time to replace it.
