# CORNERSTONE HOME INSPECTIONS

This home inspection report was prepared by **Aaron Phillips** o/a **Cornerstone Home Inspections** for **SAMPLE** on **MONTH DAY, YEAR**, at **ADDRESS, CITY**. This home inspection was done to the Standards of Practice of the International Association of Certified Home Inspectors.

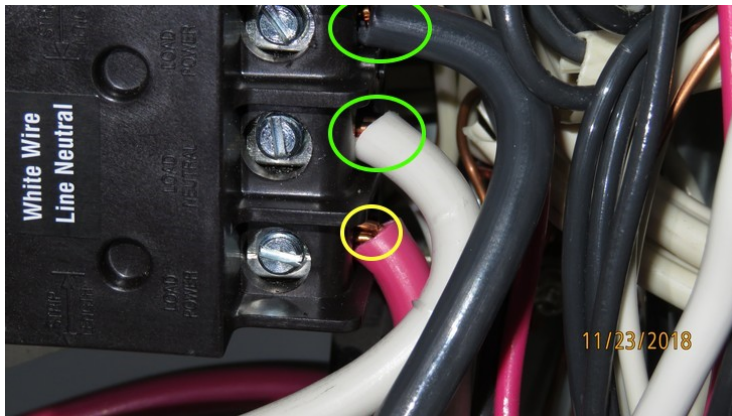
6.19

**All three stranded wires were damaged.** This happens when stripping the sheathing from the wires and is a sign of poor workmanship. This can cause the wires to overheat.

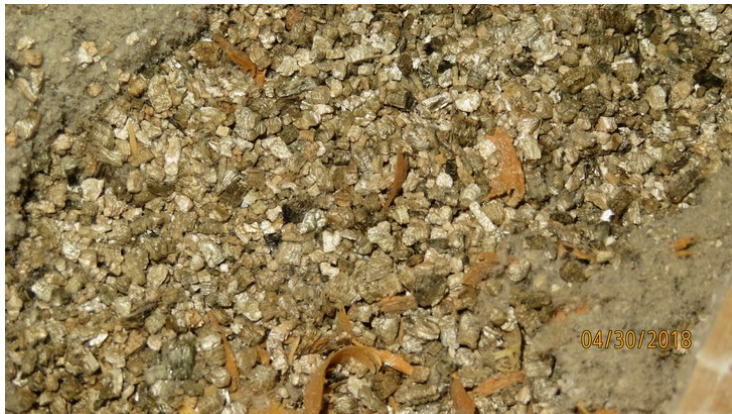
6.21

**Hazardous material, vermiculite insulation containing asbestos.** While this is a rare find, it can happen in some homes of a certain age.

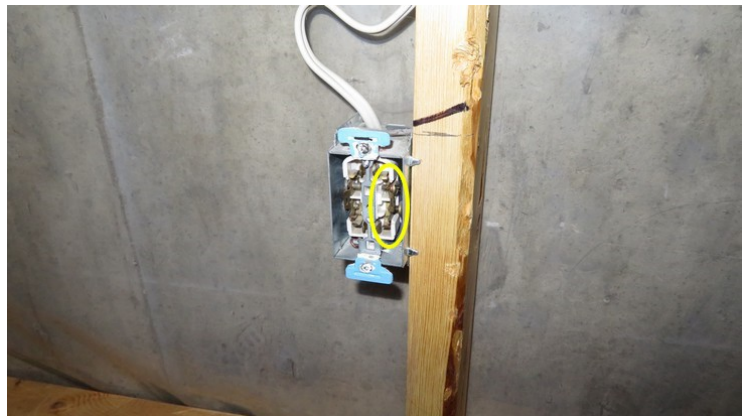
6.20

**This is an extremely dangerous situation.** This damaged outlet is connected to a live circuit. Anything that touches the metal inside the circled area will be touching live electricity.
